Document # DRD-0118-0XXX

Redress/Rebuild Procedures: NeoHybrid Positive Displacement Bailer System Dump Bailer Actuator (NeoHybridPDB DBA)

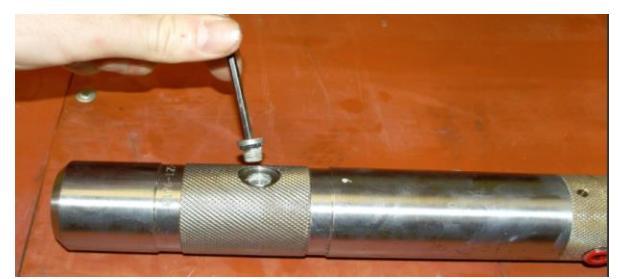
Figure 1: #2 Parker Plug removed and replaced on the Electrical Contact Sub

- Refer to drawing 0118-XXX-001 to identify features and individual parts of the Neo Dump Bailer Actuator (NeoDBA). (XXX=175 for 1-3/4" NeoDBA, XXX=213 for 2-1/8" NeoDBA, XXX=250 for 2-1/2").
- 2. Orient the **NeoDBA** so that it is easy to disassemble on a clean, flat table.
- 3. Locate the #2 Parker Plug (Item 22) near the top of the **Neo**DBA on the Electrical Contact Sub (Item 1). Remove and replace this #2 Parker Plug.

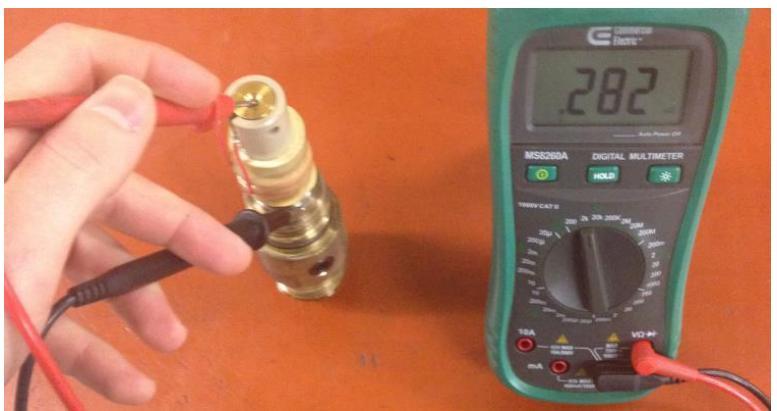
Figure 4: Checking the Resistance of the Solenoid Coil

- 7. Remove and replace quantity 2, external O-Rings (Item 25) located on the Dual Valve Tandem Sub (Item 6).
- 8. Ensure that the Solenoid Sub-Assembly (item 5) is reading 290 +/- 50 ohms. If the solenoid coil resistance reading is out of this range, replace it from the

system. There is a potential chance to fail while firing down hole. See the following figure.

21. Once both sub-assemblies are connected, once again check with the ohmmeter; the reading on the solenoid should be 290 ohms +/- 50 ohms.

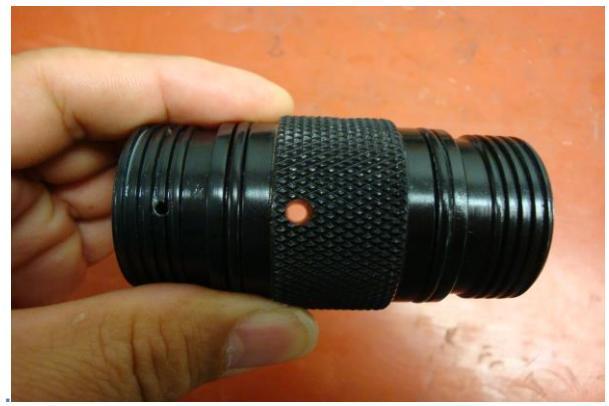
Figure 5: Holes on Dual Valve Tandem Sub where the Oil is Expelled

9. Clean the Dual Valve Tandem Sub (item 6), flushing both holes from where the oil is expelled. These ports occasionally are fully covered with sediment or debris from the wellbore.

- b) Ensure that the oil outlet ports in the Dual Valve Tandem Sub (item 6) are free of debris, sediment etc. Flush it with W-40 and air.
- c) When the actuator is fired in wells with fluid and gas presence, be careful doing the maintenance as the actuator can be loaded with trapped gas. Slowly remove the #2 Parker Plug (item 22), and use your PPE.

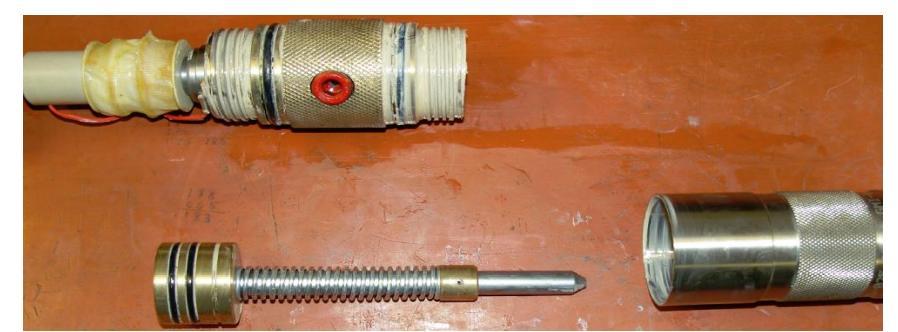
Figure 6: Piston and PDB Collet Rod removed from Spring and Piston Housing.

10. Remove the Piston (item 9) and PDB Collet Rod (item 8) from the Spring & Piston Housing (item 7).

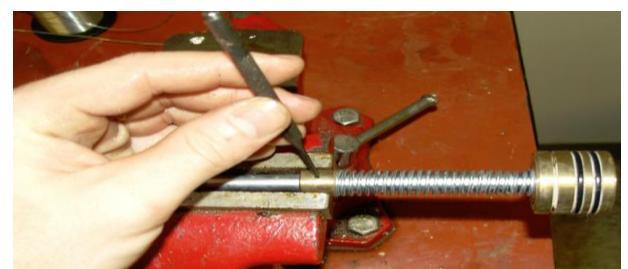
Figure 7: Spirol Pin being tapped out of the Spring Pedestal

Place the Piston (item 9) & PDB Collet Rod (item 8) in a vise. Slightly tighten the vise on the Spring Pedestal #1 (Item 10) just enough to hold the sub-assembly in place. Use a punch to tap the Spirol Pin (Item 33) out of the Spring Pedestal #1.
* Note: If you are rebuilding the tool, remove and replace the Spirol Pin.

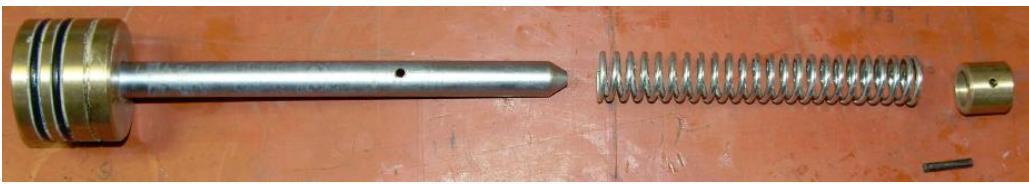
Figure 8: Spirol Pin, Spring Pedestal, and Spring removed from PDB Collet Rod

13. Once the Spirol Pin (Item 33) is out, remove the Spring Pedestal #1 (Item 10) and the Spring: 3676 (Item 31) from the PDB Collet Rod (Item 8).
* Note: If you are rebuilding the tool, remove and replace the Spring: 3676.

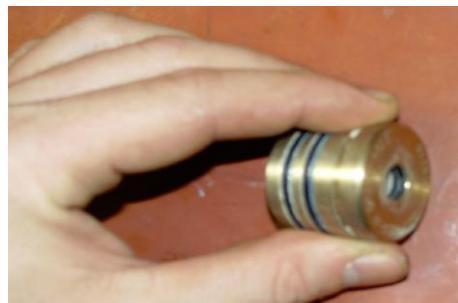
Figure 10: External and Internal O-rings found on the Piston.

15. Replace the quantity 2, external O-Rings (item 29) located at the top of the Piston (Item 9). Quantity 1, internal O-Ring (item 30) is located at the bottom of the Piston. Carefully remove & replace this O-Ring using the pick remover. **Note**: Ensure that you do not damage the O-Ring while inserting it inside the Piston.

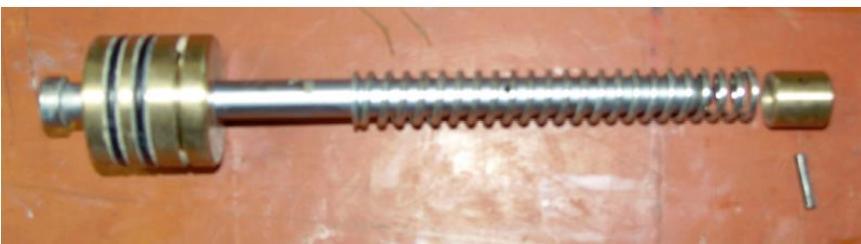
Figure 11: Sliding the Piston, Spring, and Spring Pedestal back onto the PDB Collet Rod

16. Slide the Piston (Item 9) back onto the PDB Collet Rod (Item 8), followed by the Spring (Item 31) and the Spring Pedestal #1 (Item 10). The Spirol Pin (item 33) will have to be tapped back through the Spring Pedestal #1 and PDB Collet Rod. Note: Ensure that the PDB Collet Rod is free of any sharp edges. Sharp edges can cut the O-Ring seal (item 30). Lubricate the PDB Collet Rod before inserting the Piston.

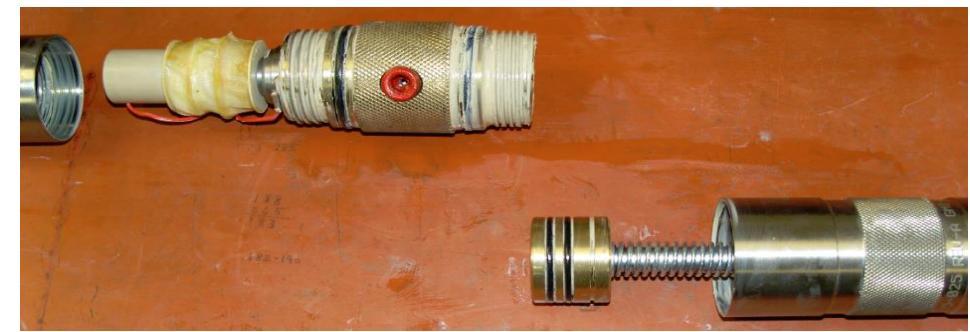
Figure 13: Piston and PDB Collet Rod inserted into Spring and Piston Housing

17. Insert Spring: D-1153 (item 32), the Piston (Item 9), and PDB Collet Rod (Item 8) back into the Spring & Piston Housing (Item 7). Lubricate the piston with proper grease.

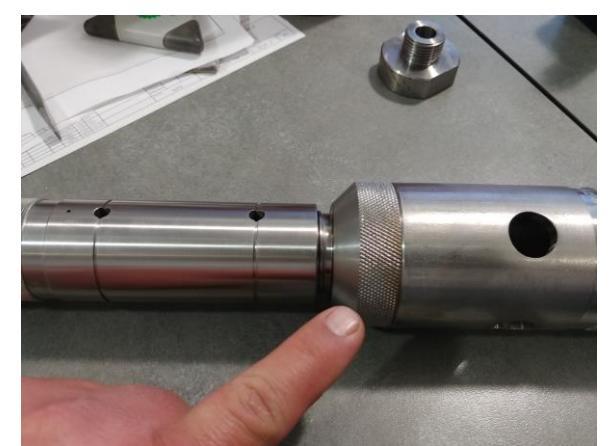
22. Unthread the Tandem Sub (item 11) and upper portion of the tool from the Spring Housing (item 12).

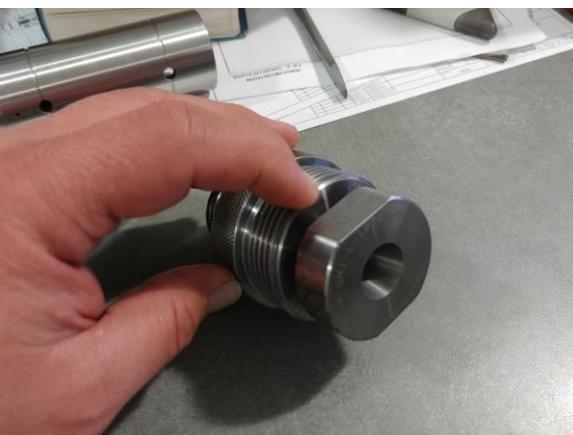
23. Unthread the Collet Base (item 13) from the Tandem Sub (item 11). Note: Ensure that the two components are internally clean from debris caused from the grease injection or sediment from the well. Here is where the collet is engaged and positioned while the tool is lowering down hole. Make sure both parts are free of debris.

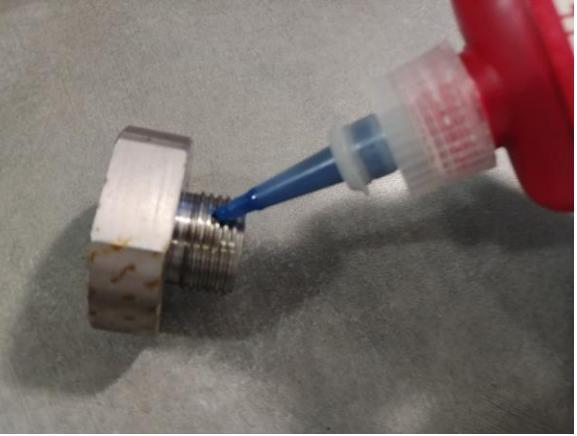
24. After cleaning, apply Loctite 243 to the collet base thread and thread the collet base back onto the Tandem Sub.

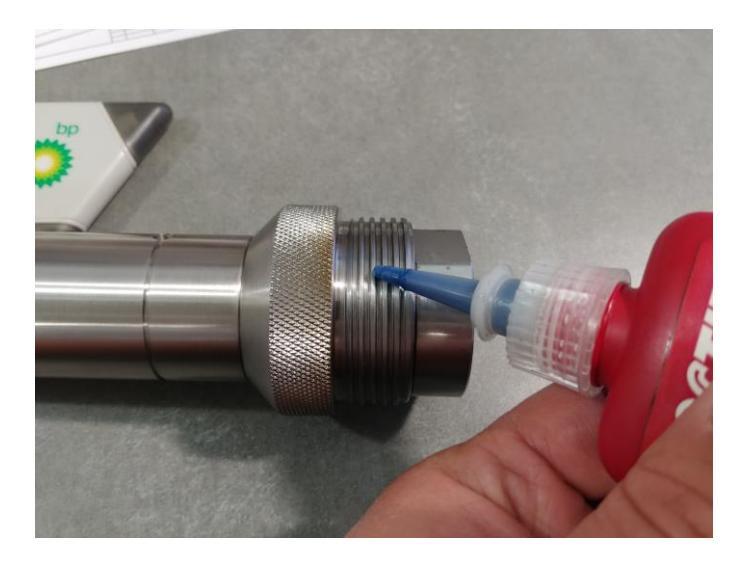
- 26. Place the Die Springs (item 34) back into the Spring Housing (Item 12).
- 27. Apply Loctite 243 to the tandem sub large thread, then thread the sub back onto the Spring Housing back onto the Tandem Sub (item 11).

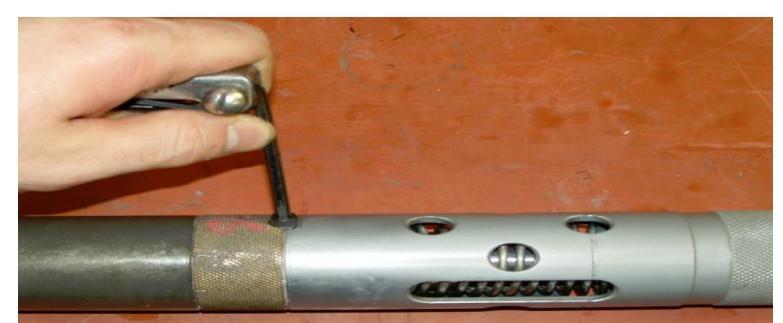
Figure 15: Socket Head Cap Screw removed from Lower Housing Sub-Assembly

31. Remove the Socket Head Cap Screw (Item 18) from the Lower Housing Sub-Assembly (Item 17).

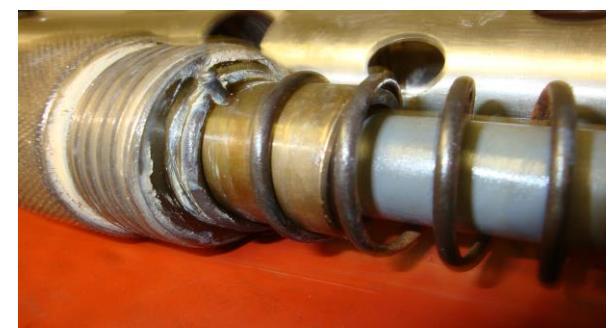
Figure 17: Lower Tandem Sub with Roll Pin and Compression Spring

33. Ensure that the Roll Pin (item 39) & the Compression Spring (item 35) are in place.

34. Clean the Lower Tandem Sub (item 17a) from any existing debris.

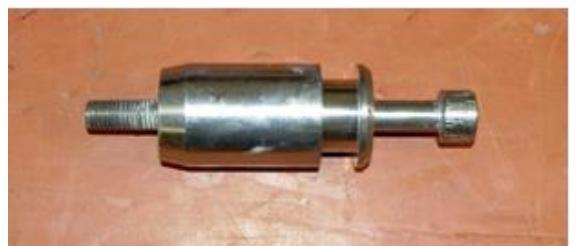
Figure 18: Slotted Slide and Swab Piston removed from Lower Extension Rod

- 35. Remove the Slotted Slide (item 20). **Note**: Inspect this impact screw since the force discharged from the spring is tremendous. Look for any damaged threads, dents, etc.
- 36. Replace the Viton Poly Pack (Item 37) located on the Swab Piston (Item 21). Make sure the lip of the Poly Pack is facing down; refer to the drawing for reference.

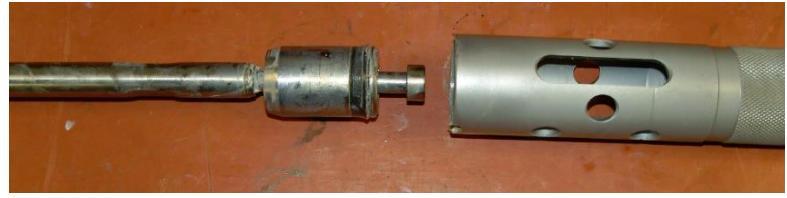
Figure 20: Slotted Slide threaded back onto the Lower Extension Rod

- 38. At this time, you can slide the Lower Extension Rod (item 19) through the Lower Tandem Sub (item 17a) and then unthread this Lower Extension Rod from the Spring Pedestal #2 (item 16). Clean and grease the threads before threading these two components back together. Insert the Lower Extension Rod back through the Lower Tandem Sub.
- 39. Slide the Swab Piston (Item 21) back onto the Slotted Slide (Item 20) and thread the Slotted Slide back onto the Lower Extension Rod (Item 19).

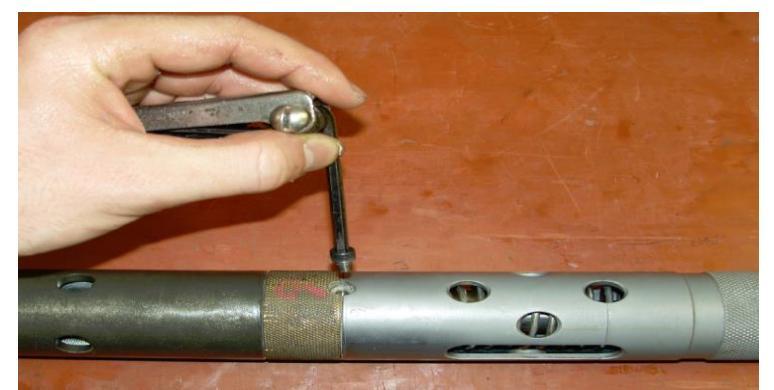
Figure 21: Socket Head Cap Screw screwed into the Lower Housing Sub Assembly

40. Slide the Lower Piston Housing (Item 17b) back over the Swab Piston (Item 21) and thread the Lower Piston Housing onto the Lower Tandem Sub (Item 17a). Insert the Socket Head Cap Screw (item 18) back into the Lower Housing Sub Assembly (Item 17).

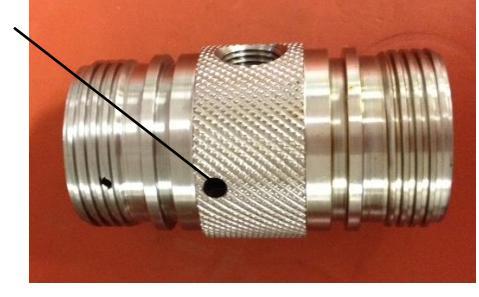
Hydraulic fluid leak from this location represents a faulty solenoid valve

Note: Check for hydraulic fluid leaks from the actuator once the tool has been filled with hydraulic fluid. If hydraulic fluid continuously leaks from the two discharge holes on the Dual Valve Tandem Sub (Item 6), the Solenoid Valve from the Solenoid Sub-Assembly (Item 5) needs to be replaced. If hydraulic fluid continuously leaks from the Hydraulic Fill Port on the Dual Valve Tandem Sub, the C200 Series Cartridge Seal (Item 27) needs to be cleaned and/or replaced.

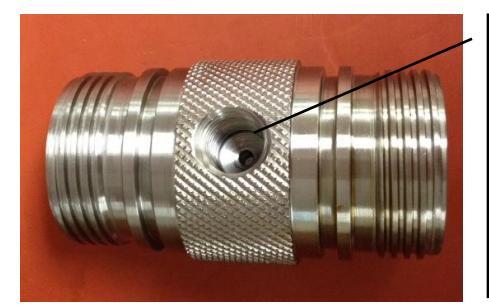
Hydraulic fluid leak from this location represents a faulty C200 Series Cartridge Seal
